Ceramic Liner Fracture in Total Hip Arthroplasty: A Case Report

Baikozho R. Tashtanov¹, Andrey A. Korytkin¹, Vitalii V. Pavlov¹, Igor I. Shubnyakov²

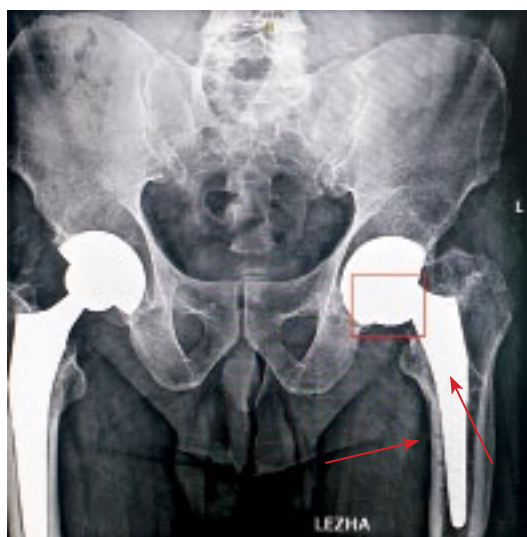
Fig. 1. Overview X-ray of the hip joints: on the right — a total hip replacement with a cementless proximal fixation (2019); in the left — a total hip replacement with a cementless proximal fixation. Dislocation of the elements of the bearing (highlighted in red). The arrows indicate the canals after removal of the screws

Sequential X-ray methods of research using plain pelvic radiography in the antero-posterior view revealed a satisfactory inclination of the acetabular component, a varus position of the femoral component of 10°, and a distortion of the endoprosthesis contours in the lower region of the acetabular component and the femoral neck component, which was regarded as a fracture of the ceramic liner or head that make up the bearings. Signs of a previously installed DHS surgical hardware, as well as channels from previously inserted cortical and dynamic screws, were visual-

ized in the cortical area in the upper third of the diaphysis of the left femoral bone after removal in the diaphyseal and subtrochanteric regions (Fig. 1, 2).

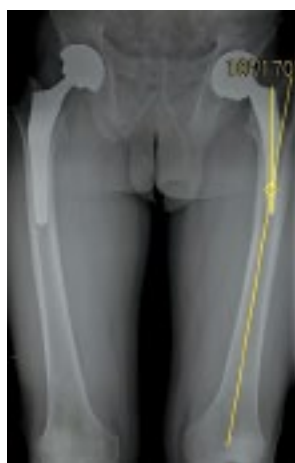
Fig. 2. Overview X-ray of the hip joints with full femoral capture. On the left is a 10° varus placement of the femoral component

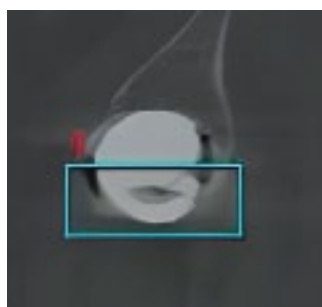
Fig. 4. MSCT, sagittal projection: fracture of the ceramic liner

A fracture of the acetabular liner on the left was diagnosed (Fig. 4). A histological examination of the puncture sample was not performed since radiological diagnostic methods were sufficient.

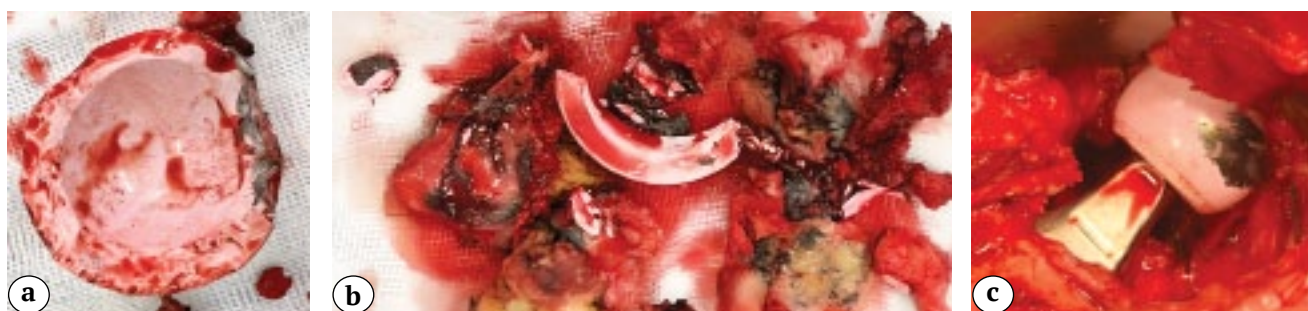
The skin, subcutaneous tissue, and fascia were dissected along the previous postoperative scar on the outer surface in the proximal third of the left thigh with the Hardinge approach in the patient's right lateral position under combined anesthesia (spinal and inhalation anesthesia). Cicatrices were mobilized in the greater trochanter area. Approximately 50 ml of odorless hemorrhagic fluid without fibrin was released when the joint capsule was opened. Multifragmentary destruction of the acetabular ceramic liner was visually registered after capsular dissection and femoral component dislocation after the Hohmann retractor installation behind the anterior and posterior columns. All seven visible ceramic liner fragments were removed, and their sizes ranged from 2×3 mm² to 20×20 mm². Repeating notch-

shaped defects were visible along the edges of the preserved large fragments of the liner (marginal zones of the liner). The head was intact. The proximal femur was mobilized, and the endoprosthesis head was removed (Fig. 5).

Fig. 5. The appearance of the ceramic liner fragments: a — a large ceramic liner fragment (central) 20×20 mm with signs of metal contact (black); b — medium (15×6 mm) and small fragments (2×3 mm) with excised surrounding tissues; c — femoral head with signs of metal contact (black)

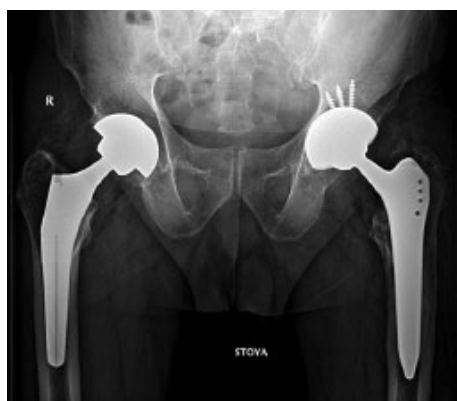
Fig. 6. Anteroposterior X-ray view of the pelvis 3 months after surgery: on the right — a total hip replacement with a cementless proximal fixation (2019); in the left — a total hip replacement with a cementless proximal fixation

aseptic dressing were used. The wound healed by primary intention. The patient was discharged on day 10. The plain radiography of the pelvis in the antero-posterior view determined that the acetabular component inclination was 35° , the femoral component was in the correct position when conducting control 3 months post-operatively, and no valgus or varus angulation was noted (Fig. 6). MSCT in the axial projection revealed that the acetabular component was implanted in the anteversion position of 17° (Fig. 7).
